Dofasco Inc. Sulfurcrete Acid Resistant Concrete Lining

STRUCTURE: Sulphuric Acid Secondary Containment
LOCATION: Hamilton, Ontario
PROJECT DATE: March 27, 2001
PRODUCT USED: Sulfurcrete Acid Resistant Concrete
MasterBuilders: SCB Concessive 1360 Epoxy
: Emaco S88 Repair Mortar
JOB DURATION: 15 Days
CLIENT: Dofasco Inc.
AREA: #2 By Products
CONTRACTOR: Vector Restoration Ltd.

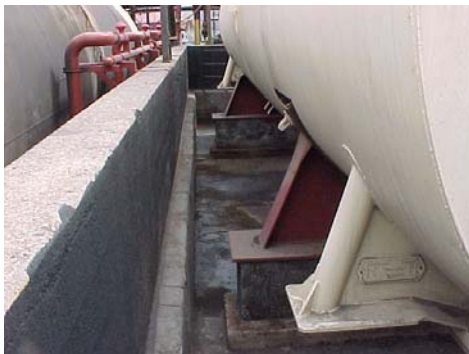
SULPHURIC ACID SECONDARY

Due to the spillage of the Sulphuric Acid over time there was reoccurring damage to the unprotected concrete surface. When the integrity of the containment ability of the structure became an issue, the client ordered extensive repairs. Vector Restoration Ltd. designed a reconstruction package.

The damaged deteriorated portions of concrete surface were repaired using Emaco S88 Repair Mortar. The cracks in the structure were repaired using the SCB Epoxy injection system. The tank Secondary Containment area floor and the walls to a height of 36" were lined with a 6" thick layer of Sulfurcrete Acid Resistant Concrete.
