Concrete Gallery Roof Restoration

STRUCTURE:	Water Pollution Control Plant
LOCATION:	Thunder Bay, ON
PROJECT DATE:	September 1999
PRODUCT USED:	Qualideck Flexible Coating System
JOB DURATION:	2 weeks
CLIENT:	City of Thunder Bay
CONTRACTOR:	Vector Construction Group

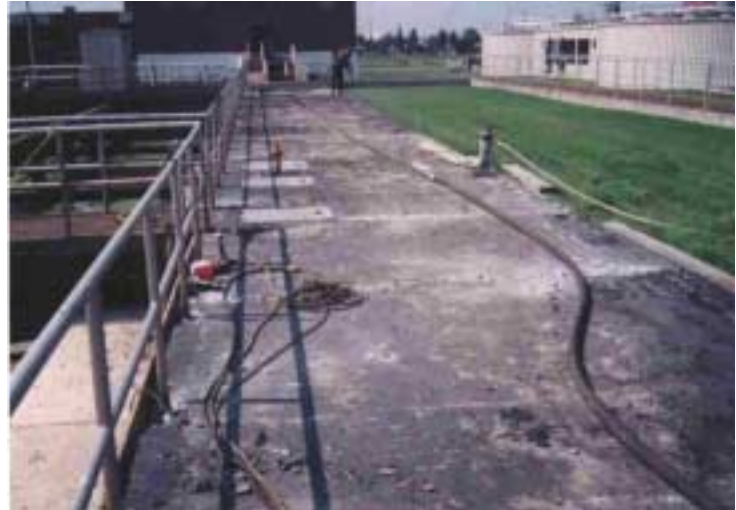
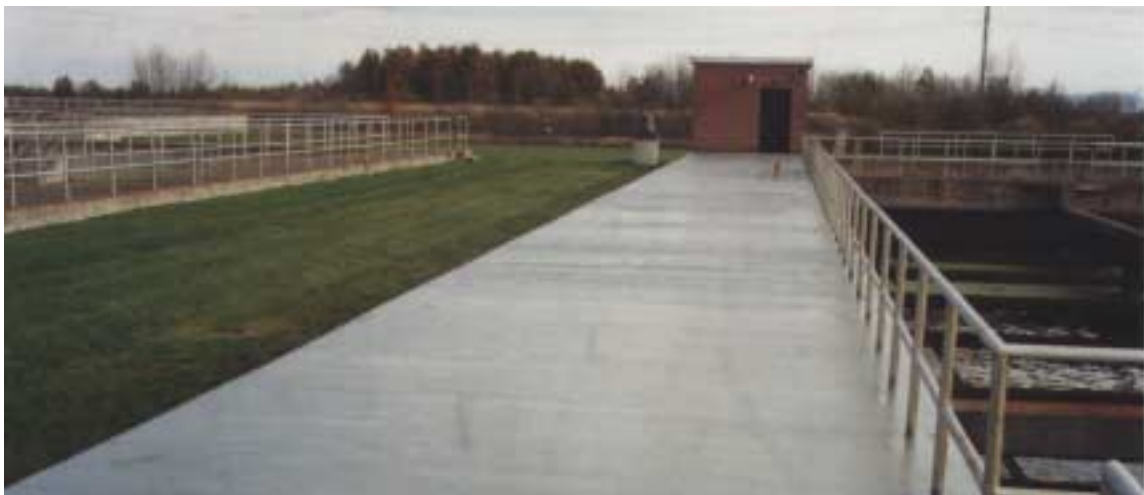
The concrete gallery walkway had deteriorated and was causing leakage into the gallery tunnel below. First the old coating and deteriorated concrete was removed. The surface of the area was then prepared, formed and 2 inches of concrete was poured over it. After 28 days of curing a three part Qualideck flexible coating system was installed over the new concrete. Finally the area was seeded to provide a slip resistant walkway.
