Dofasco Inc. Sulfurcrete Acid Resistant Concrete Lining

STRUCTURE: Sulphuric Acid Secondary Containment
LOCATION: Hamilton, Ontario
PROJECT DATE: March 27, 2001
PRODUCT USED: Sulfurcrete Acid Resistant Concrete
MasterBuilders: SCB Concessive 1360 Epoxy
: Emaco S88 Repair Mortar
JOB DURATION: 15 Days
CLIENT: Dofasco Inc.
AREA: #2 By Products
CONTRACTOR: Vector Restoration Ltd.

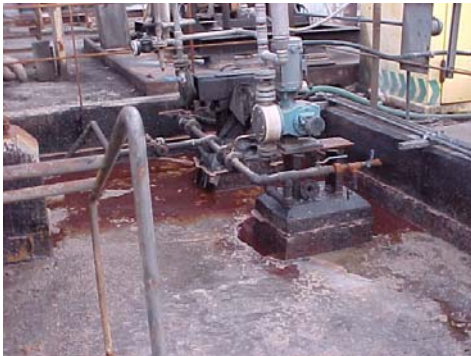
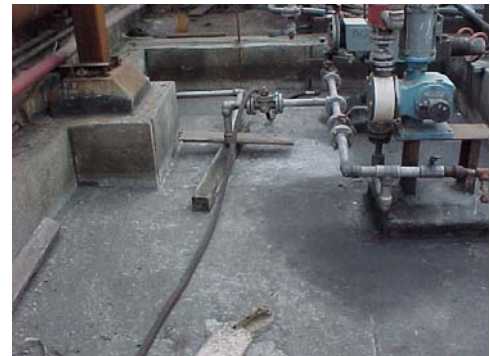
THE ACID UNLOADING PUMP PIT

Due to the spillage of the Sulphuric Acid over time there was reoccurring damage to the coated concrete surface. When the integrity of the containment ability of the structure became an issue, the client ordered extensive repairs. Vector Restoration Ltd. designed a reconstruction package.

The damaged deteriorated portions of concrete surface were repaired using Emaco S88 Repair Mortar. The cracks in the structure were repaired using the SCB Epoxy injection system. The tank Secondary Containment area floor and the walls to a height of 36" were lined with a 6" thick layer of Sulfurcrete Acid Resistant Concrete.
