United Grain Growers Leg Pit Repairs Thunder Bay, Ontario

PROJECT DATE: **July, 2001**

PRODUCT USED: 3M 5600 Urethane ThoRoc SP20

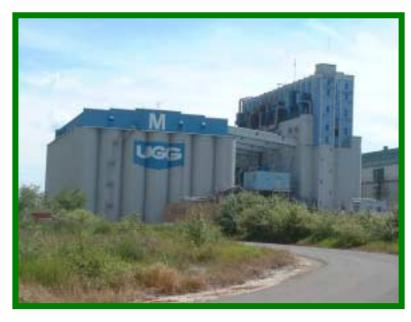
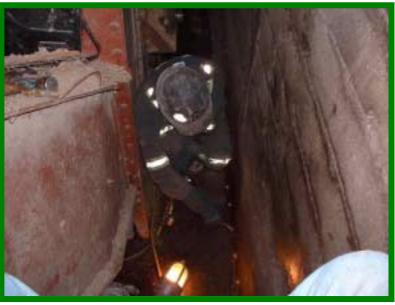
Vector was hired to repair the water leaks in the leg pits. The leaks were caused by cracks in the concrete and that the pits are approximately 10 feet below the surface of the lake. Holes were drilled along the crack and ports installed then 3M 5600 was injected through the ports into the crack to stop the leaks.
