Power Plant Acid Containment Sump Restoration

STRUCTURE: Acid Containment Sump
LOCATION: Antelope Valley Station, Beulah ND
PROJECT DATE: Fall 2001
JOB DURATION: 3 weeks
CLIENT: Basin Electric Power Cooperative
CONTRACTOR: Vector Construction Group

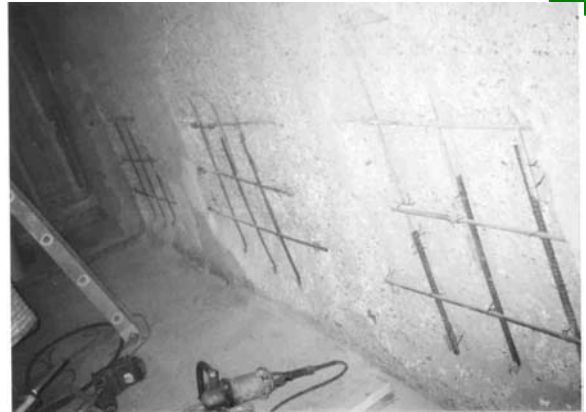
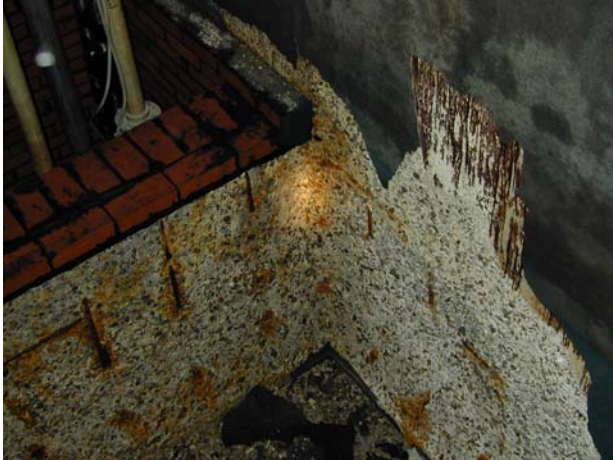
Years of chemical exposure had caused significant chemical attack to the concrete walls and floor of the acid containment sump. Work on this project consisted of the following:

1. Removal of existing failed coating system.
2. Removal of 5' high concrete wall and tile wall along with removal of all contaminated concrete.
3. All concrete spalls on the walls were cleaned, formed and patched with concrete.
4. Installation of 5 yrd³ of concrete to re-slope the floor to ensure proper drainage.
5. Installation of a ChemcCo chemical resistant coating.
