Corn Processing Plant Chemical Neutralization Tank Restoration

STRUCTURE: Pre-Neutralization Tank
 LOCATION: Wahpeton ND
 PROJECT DATE: Fall 2001
 JOB DURATION: 1 week
 CLIENT: Cargill Corn Processing
 CONTRACTOR: Vector Construction
 Group

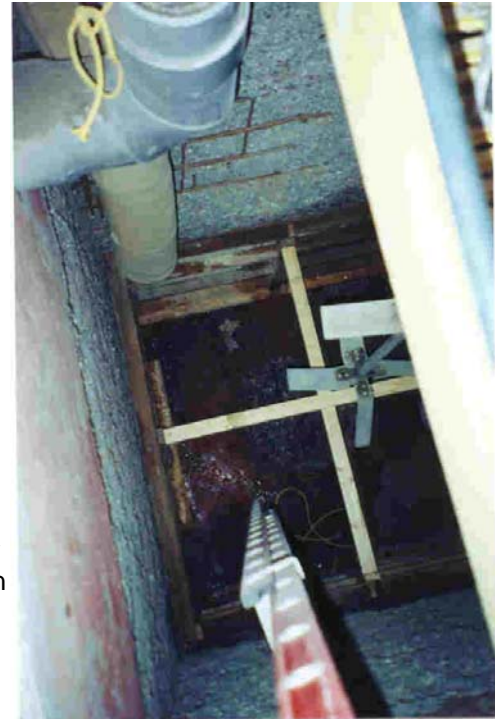
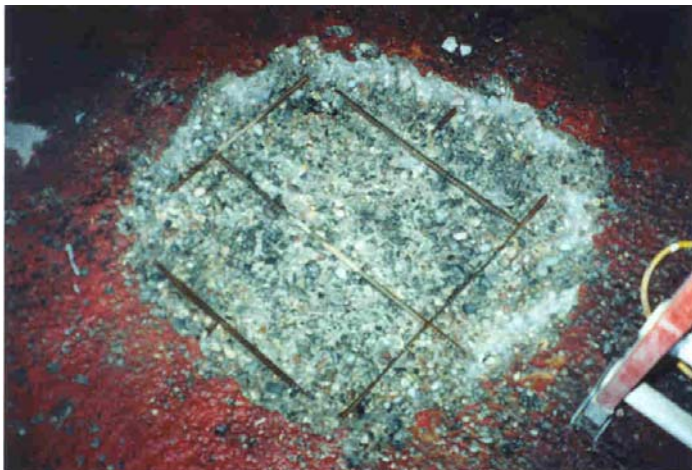
Years of chemical attack have caused significant structural damage to the concrete chemical neutralization tank at the water treatment plant of the corn processing plant. Vector Construction was contracted to develop a repair procedure to meet the long term chemical exposure of the tank while completing all work within a short shutdown window.

Work consisted of removing the existing failed concrete coating along with all contaminated concrete. All concrete repairs were completed with a fast setting engineered repair mortar so as to allow the installation of the coating system without the usual curing time of 28 days as with standard concrete repairs. Once the concrete repair had been completed a Ceilcote 505 fiberglass reinforced epoxy coating system was installed.
